Analysis of power distribution transformers' failure in rural electrification projects in Kenya.

*Ephantus Kamweru*¹, *Erastus Musyoka*¹

¹Rural Electrification and Renewable Energy Corporation (REREC), Nairobi, Kenya

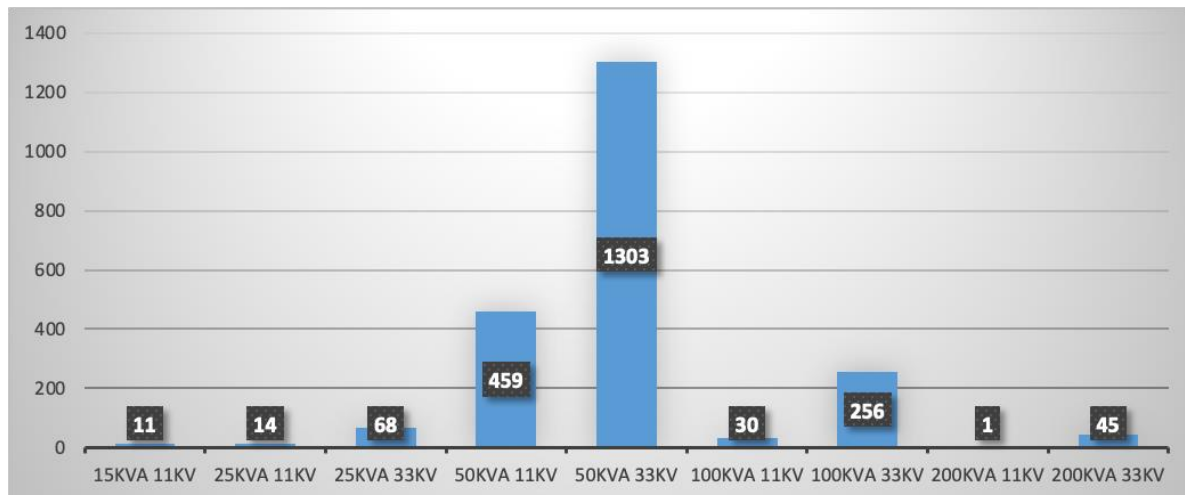
Figure 3: Bar graph on Transformer Failure Rate per Size

Further, categorizing the analysed sample into ratings, the 33kV distribution lines were the most affected juxtaposed to the 11kV lines as indicated by the majority of failed transformers rating at 50KVA/33kV followed by 100KVA/33kV as shown in figure 3. From figure 4, it is also indicative that most of the transformers were procured from India as compared to other nations and thus the high failure rate.

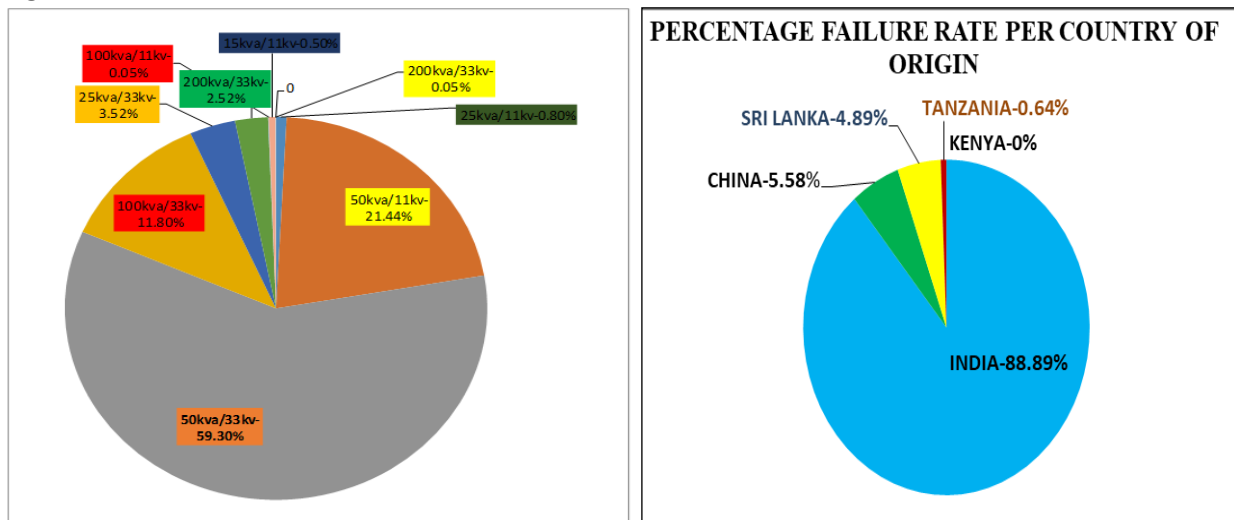
Figure 4: Failure rates per transformer ratings and Country of origin

The main cause of transformer failures highlighted above was observed to be due to improper insulation of the windings. Since the transformer insulation is by oil and paper; poor quality or contaminated oil appeared to be a major contributing factor to these failures.

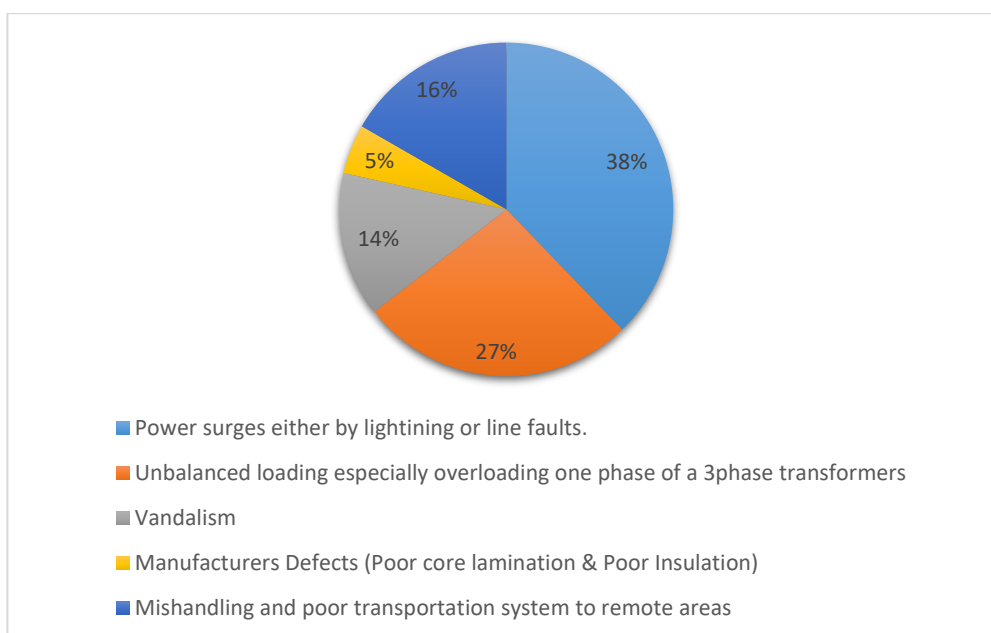
Figure 5: Main Causes of Transformer Failures

As it can be deduced from the above observations, power surges either from lightning strikes, short-circuit faults or grounding faults have been the greatest contributor to transformer failures which could be due to insufficient protection systems in the grid. Power surges either due to natural impulses like lightning or technical impulses during switching, causes undue stress on the transformer insulation consequently weakening the insulation cover of the windings and flashovers between ground and weakest point of the phase windings (Al-Arainy, Malik and

Qureshi, 2012). This causes broken circuits in the HV windings, bursts of the windings and tanks, soot in the oil and burnt terminations. Reliable grid line and substation protection systems such as overhead surge arrestors should be installed appropriately to arrest these power surges and ground faults when they occur (Predota, Benesova and Koudela, 2012). To increase the reliability of these protection systems, transformers are currently installed with on-transformer-mounted surge arrestor in addition to the conventional one span protection system (IEEE Guide for the Application of Surge-Protective Devices for Use on the Load Side of Service Equipment in Low-Voltage (1000 V or Less, 50 Hz or 60 Hz) AC Power Circuits, 2016). Also good securing of the transformers cuts on the vandalism of grounding systems which protects the transformers against surges.

Cases of transformer theft and vandalism are still rampant in local areas exacerbating the rates of transformer failures as implied by transformers with no oil, no coils and damaged core assemblies. Transformers are also damaged during transportation in the rough roads servicing rural areas. If they are not well handled, the delicate windings configurations tend to shift which strains the terminals of the transformer coils leading to open circuits.

- i. Power distribution lines and substations should be constructed with reliable surge protection systems installed at the critical line points so as to address the impacts of power surges in the grid. Also low voltage distribution transformers should be installed with additional surge protector mounted directly across transformer bushings with as short leads as possible for additional protection in case of lightning strikes or switching impulses.

- ii. Global earthing concept, where surge arresters/protectors, transformer tank/body, line hardware and network/system ground are bonded together and earthed, should be applied.

- iii. Proper and comprehensive forecasting and predictive designs distributing the potential connections on the terminal transformers should be done to avert the effects of unbalanced loading on these distribution transformers. Continued inspection and maintenance surveys should also be deployed to ensure LV side load balancing on the transformers.

- iv. Distribution transformers should be mounted in secured areas as opposed to secluded zones to mitigate cases vandalism and oil siphoning/theft.
- v. All sourced transformers should be thoroughly inspected of defects and subjected under routine tests both at the manufacturer's location and the utility test points. Transformers with any physical defect on bushings, tanks or arching horns should not be issued for installations. In addition stringent factory assessment/acceptance tests to be implemented for every transformer.

- vi. Qualified and licenced electrical contractors and technicians should always install, commission and maintain power distribution transformers with specialized transportation equipment being used for transformers transport.
